CALSPAN ON-SITE AIR BAG DEPLOYMENT INVESTIGATION

CALSPAN CASE NO. 91-12

FLEET - 1990 DODGE SHADOW

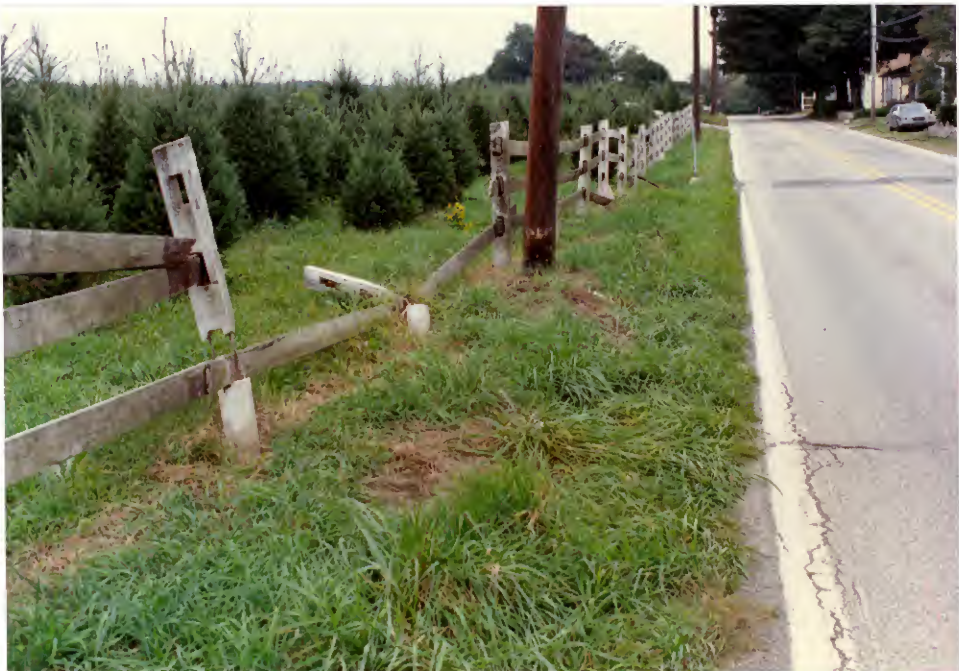
5

The left front corner area of the vehicle initially side-swiped the first fence post that was located 8'2" south of the south road edge. Damage to the vehicle was minimal which involved a shallow dent to the front third of the left front fender with paint abrasions. The damage extended 23.75" rearward on the fender before ending at a point 7.75" forward of the left front axle. The left front tire probably impacted the fence post which resulted in an airout of the tire. There was no visible damage to the tire or alloy wheel.

The vehicle continued forward and impacted a second concrete fence post with the left corner area of the front bumper. Direct contact damage began at the bumper corner and extended 5" inboard onto the bumper fascia. The concrete post impacts separated the left corner wrap-around of the bumper fascia. The extent of bumper crush was minimal, but unknown due to the bumper displacement from the utility pole impact.

Initial Impacts With The Concrete Fence Posts.

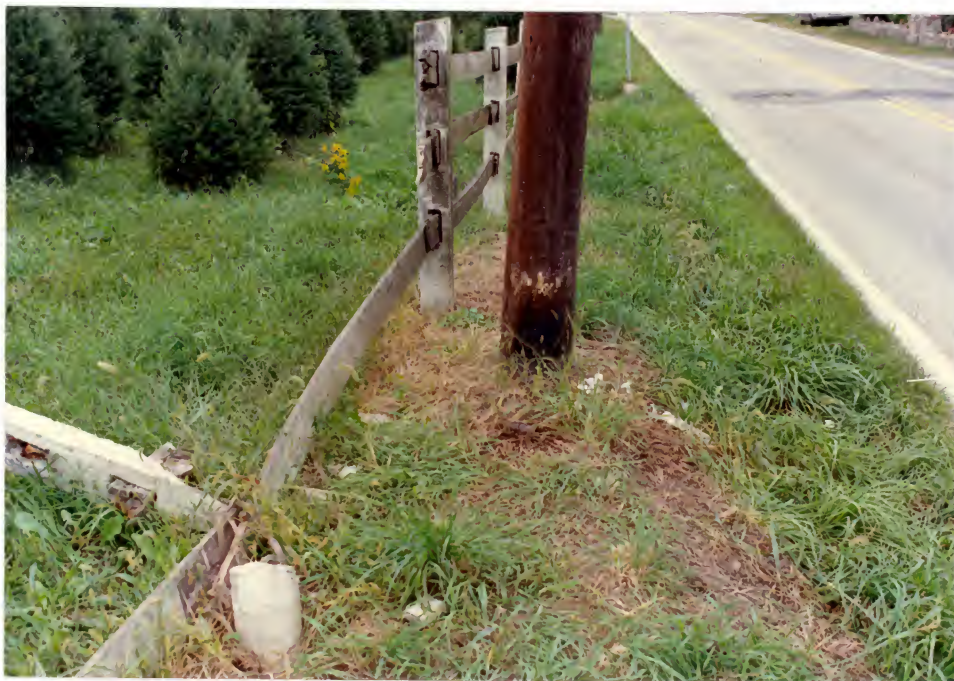
6

The Dodge Shadow continued forward and impacted a 10" diameter wooden utility pole with its center frontal area. The pole was located 5'9" west of the second struck fence post and 6'4" south of the road edge. Impact speed was computed at 16.0 mph by the damage and trajectory mode of the CRASHPC program. The 12 o'clock direction of force impact crushed the front bumper to a depth of 14.5" and also crushed the radiator support panel and hood face. As a result of the pole impact, the vehicle underwent a velocity change of 14.4 mph. The impact induced deceleration was of sufficient magnitude to deploy the vehicle's driver air bag system.

Struck Utility Pole.

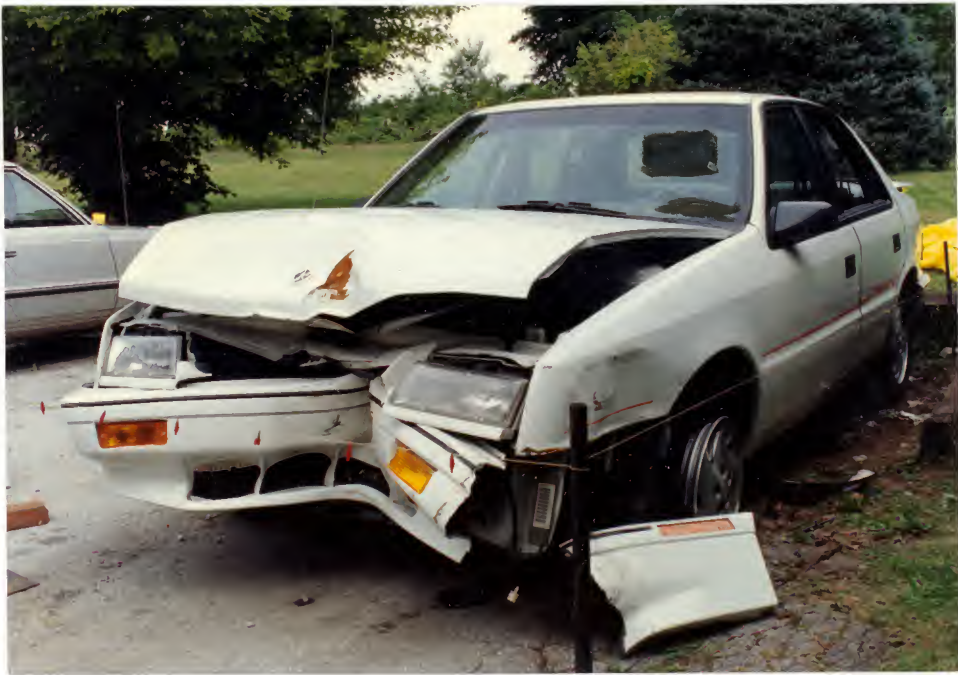
10

Left Front Three-Quarter View.

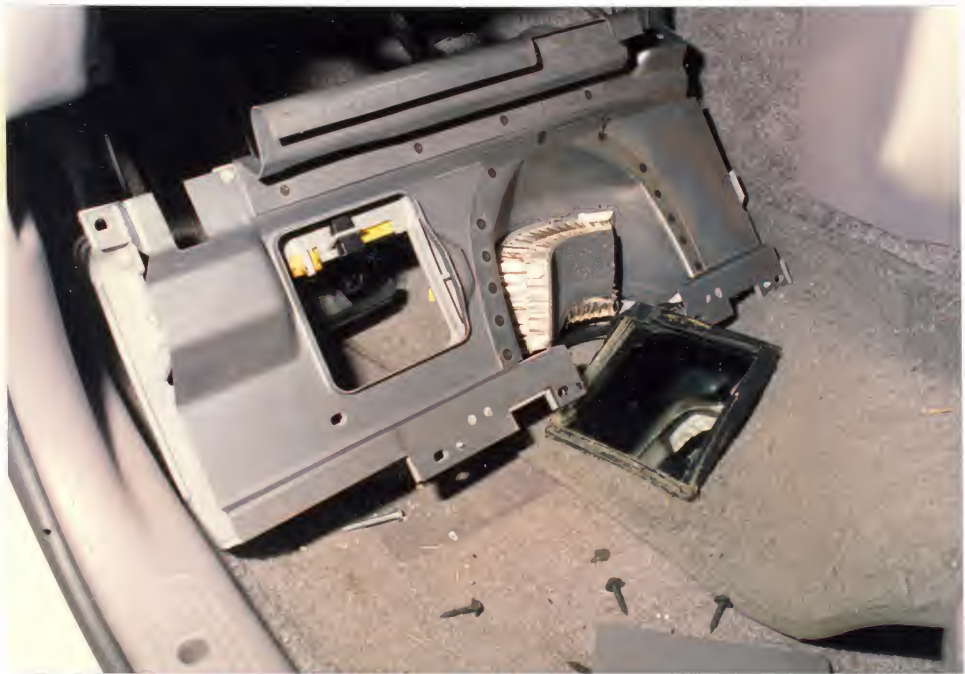
22

Steel Reinforcement To The Knee Bolster.

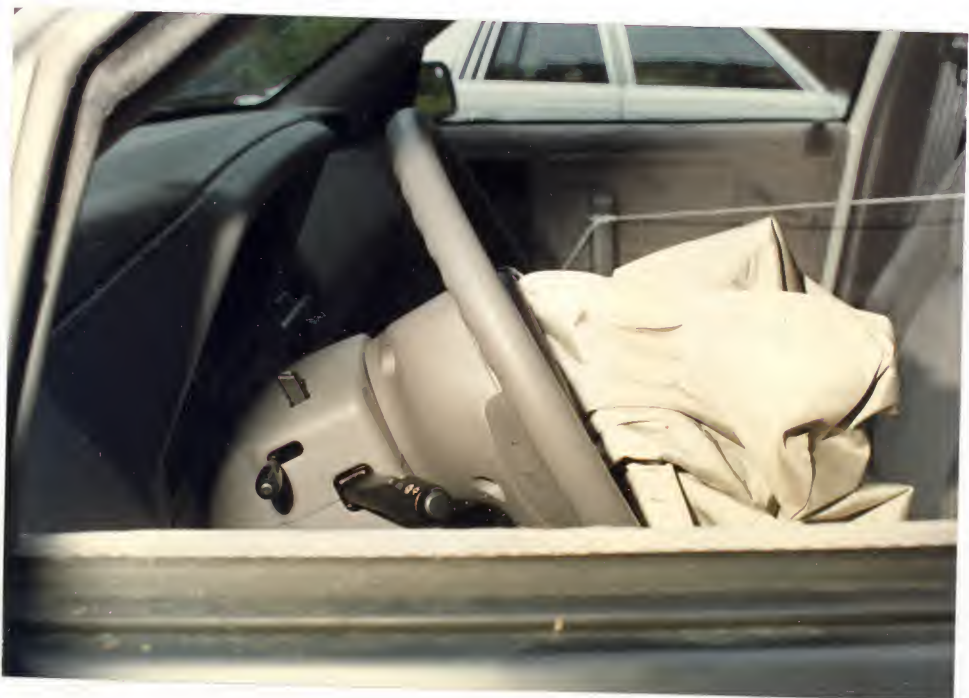
23

The air bag module was mounted to a two spoke steering wheel with the spokes located at the 4 and 8 o'clock positions. The module flaps opened in an H-configuration at the designated tear points with the upper flap measuring 6 11/16" horizontally and 2 3/8" vertically. The lower flap measured 6 3/4" horizontally and 2 9/16" vertically. There was no damage or evidence of occupant contact to the flaps.

Perpendicular View Of The Steering Assembly And Deployed Air Bag.

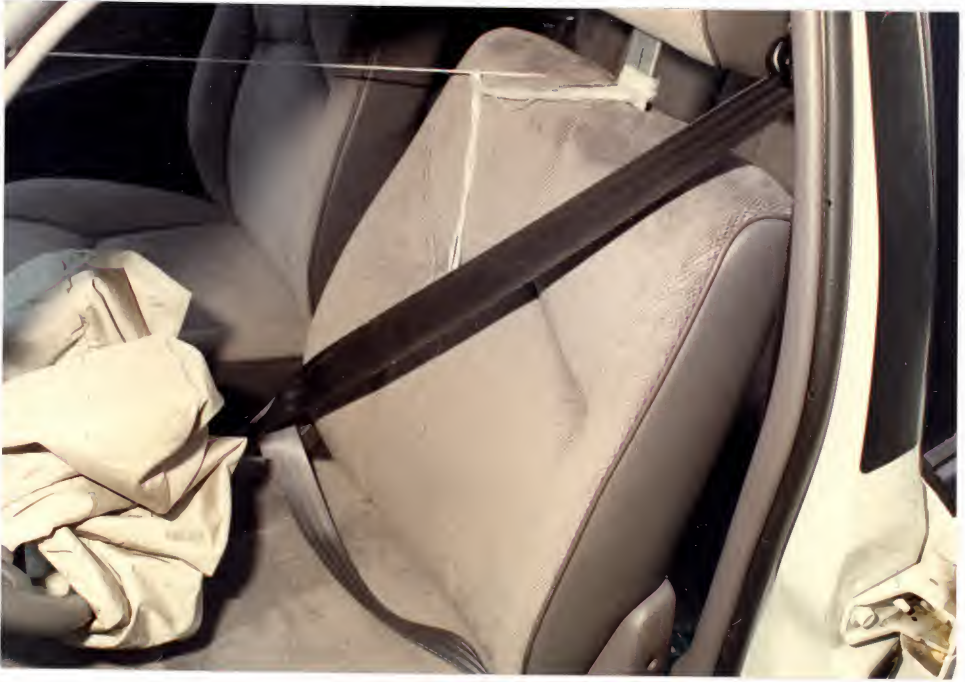
26

The driver was wearing the active 3-point lap and shoulder belt system at impact; however, due to her forward position, did not sufficiently load the belt webbing. There were no load induced stretch marks on the belt webbing or at the B-pillar mounted D-ring. The latchplate did yield several faint routine wear marks which indicated that the driver was a frequent, but not full-time belt user. As the driver slumped to her right following the impact sequence, a jewelry pin that was affixed to the left side of her dress snagged the shoulder belt webbing. The snags were located on the outside surface of the shoulder belt webbing and extended 22-26" and 30.25-36.75" vertically above the floor mounted anchor. Both snags were located .375" inboard of the belt edges. A third snag was located at both edges of the belt 36.75" above the floor anchor. The snag resembled superficial cuts at the edges and contained cloth fibers (probable dress fibers).

Driver's Seat And Active 3-point Belt System.

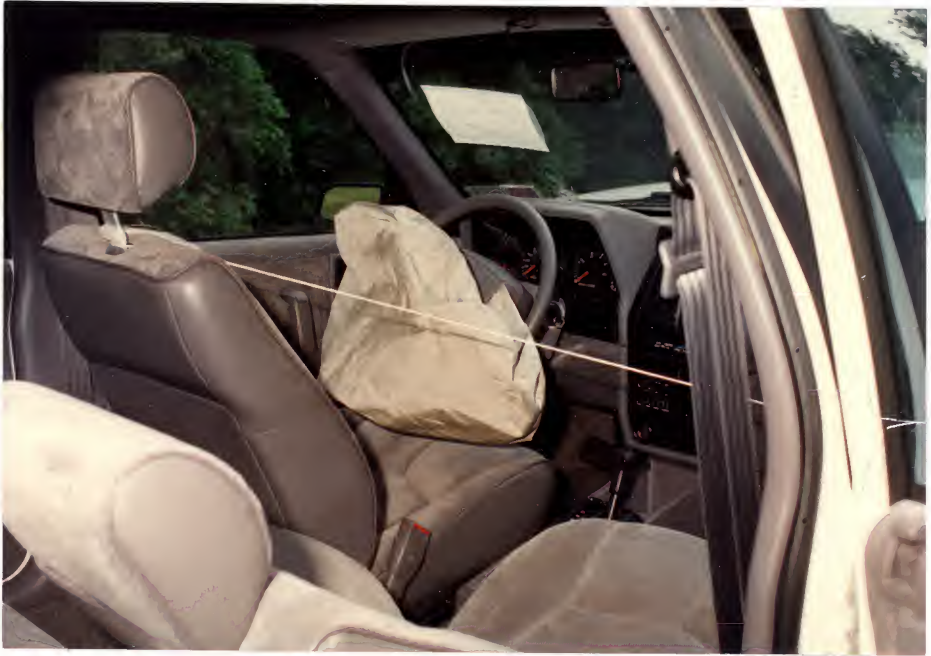
28

As the vehicle came to rest, the driver slumped to her right and probably snagged the belt webbing with the jewelry pin which ripped the front of her dress. She slid out of the shoulder belt webbing and came to rest with her head and torso resting on the right front seat cushion.

Driver Came To Rest Slumped Across Right Front Seat Cushion.

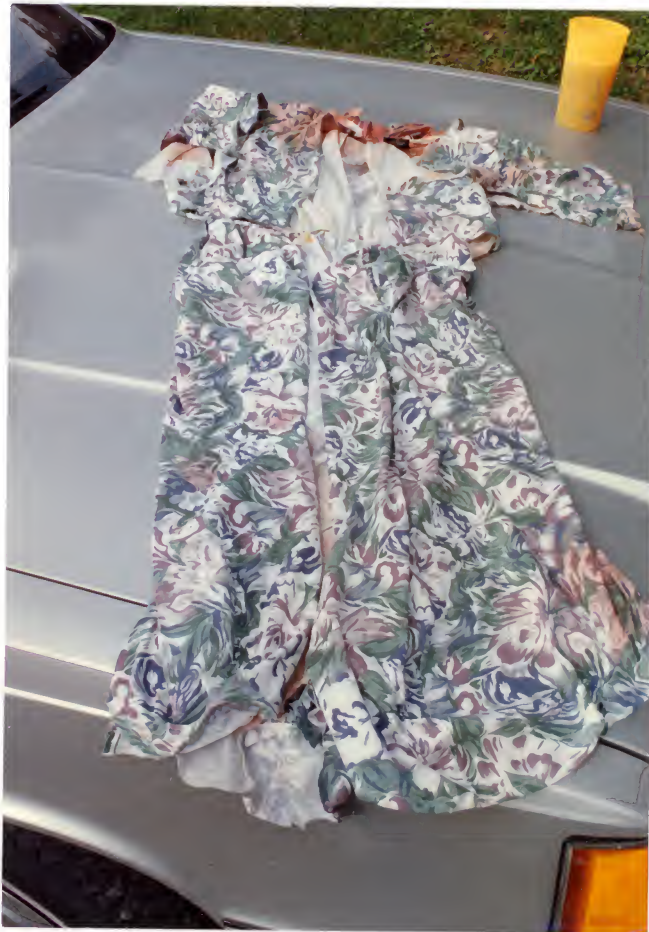
29

Dress Worn By The Driver At The Time Of The Crash.

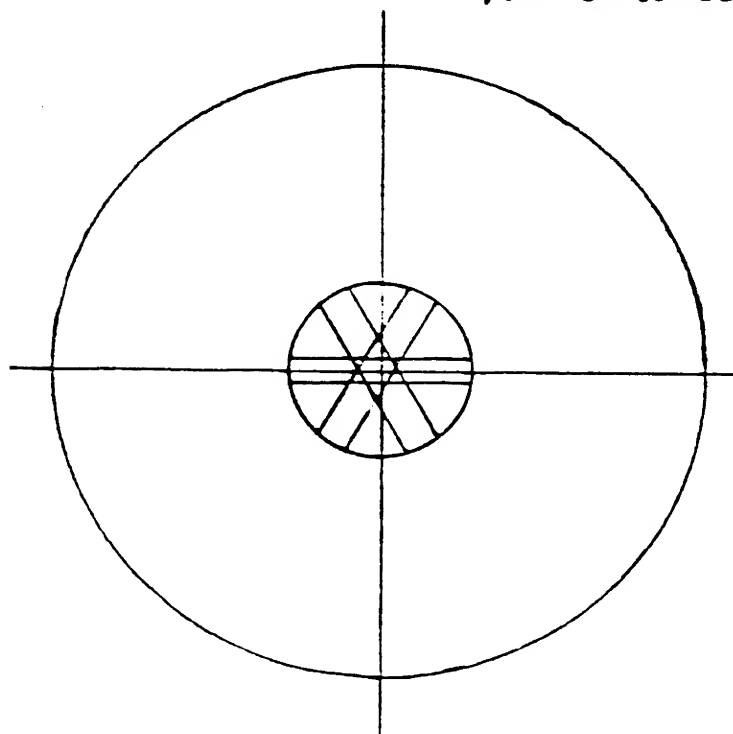
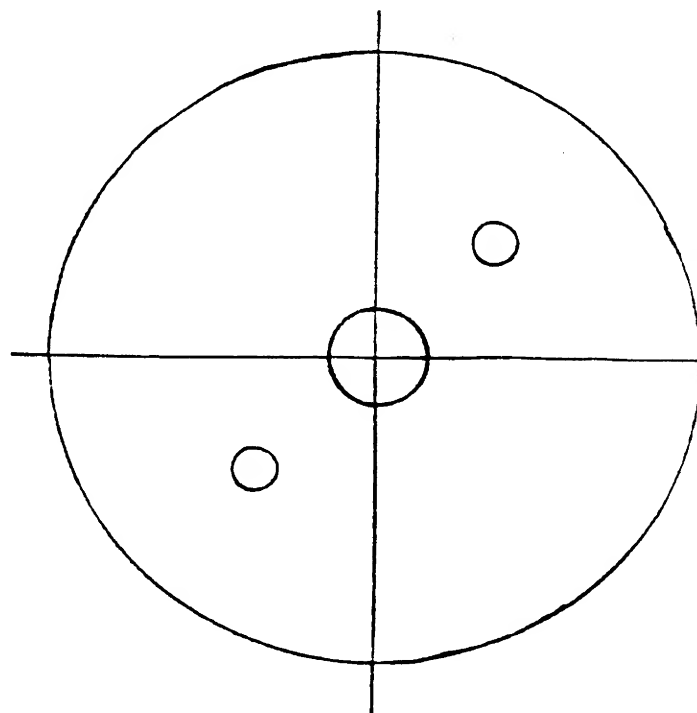
NO EVIDENCE OF BAG CONTACT

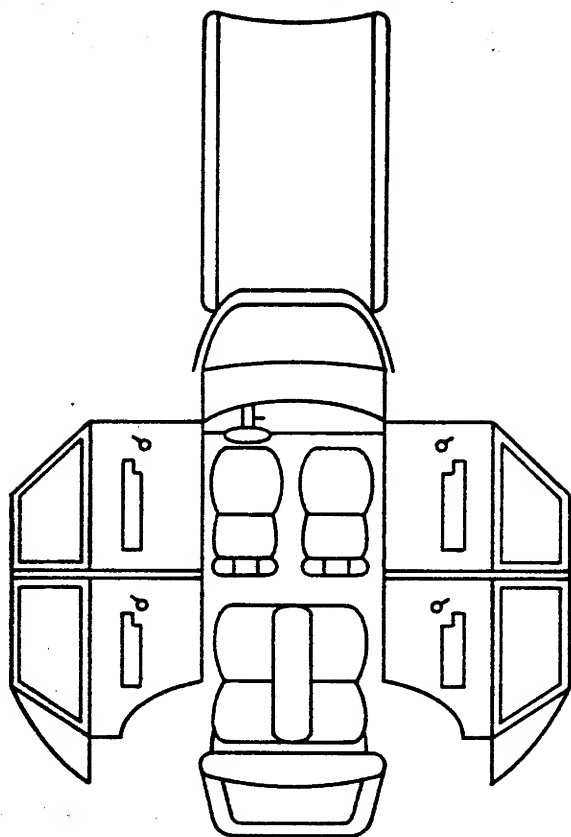
LF SEAT SET TO A FORWARD POSITION
(MOVED AT TIME OF INSPECTION)

~.25" OF
UPPER RIM
DISPLACEMENT
